# Manhole Inspection Summary

Manhole # S51M\_\_011MH

Insp Date: **9/14/09 9:45 AM**

**Location** Address: **900 S.Lakewood Ave.**

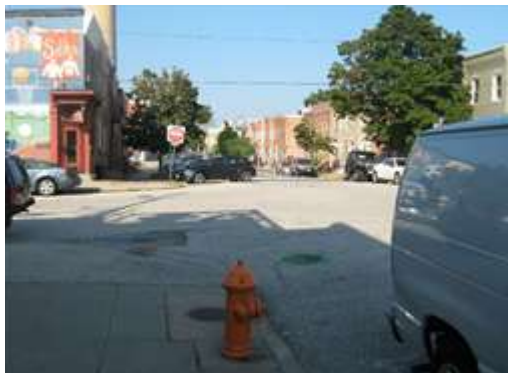
Location View

View west

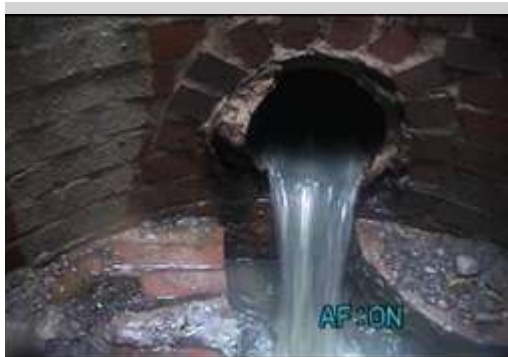
Miscellaneous

view of 9 o clock

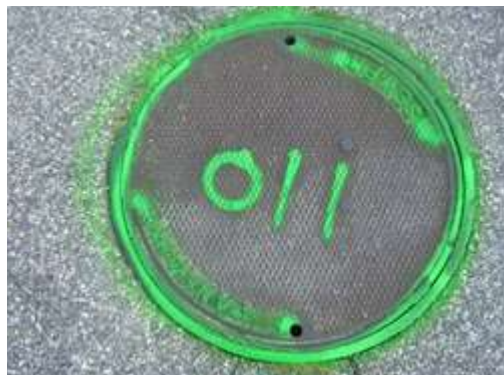
Miscellaneous

MH Lid

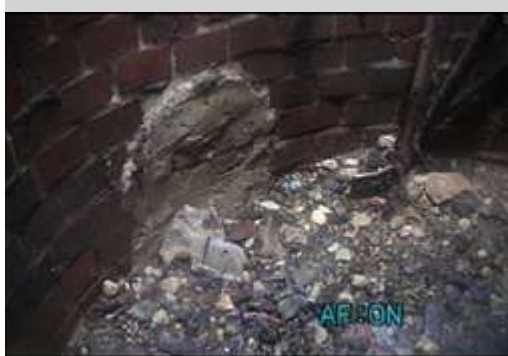
Defect 2

Condition: ☐ Sound ☐ Cracked ☐ Root Intrusion ☐ Deteriorated ☐ Leaks ☒ **Debris**

debris on the bench

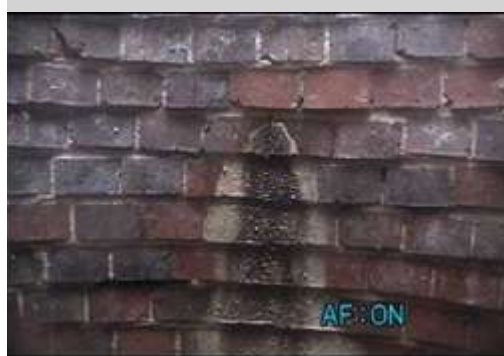
Defect 1

Infiltration: ☐ None ☐ Joint ☐ Cracks ☐ Mortar ☐ Roots ☒ **Wall**

corbel infiltration at wall

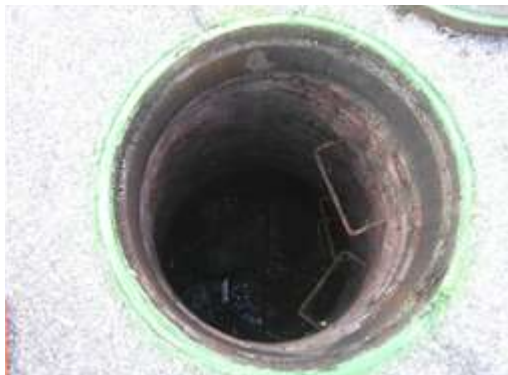
### Defect 3

Offset: **1** (in.)

frame offset

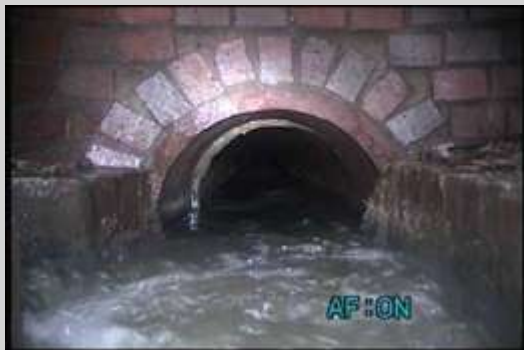
12 O'Clock Outflow

15 in. Circular Gravity Sewer  
Pipe Out @ 12 O'Clock

Pipe Height: **15.6** (in.) Rod and Bar (Angled)  
Pipe Material: **Clay** ☐ Pipe Lined  
Invert Depth: **11.80** (ft.) Flow Characteristics: **Slow**  
Deposits: ☒ None ☐ Mud ☐ Sludge ☐ Debris ☐ Grease  
Silt Depth: **0** (in.) Deposits Extent:  
Infiltration: **None** Pipe Seal Cond: **Sound**

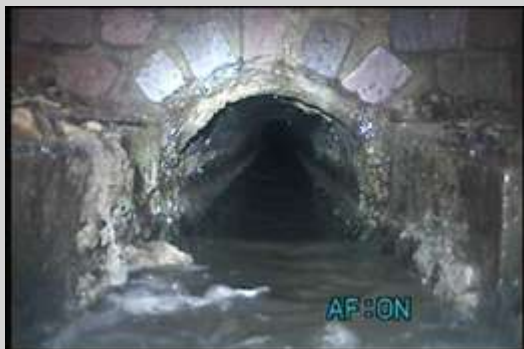
6 O'Clock Inflow

8 in. Circular Gravity Sewer  
Pipe In @ 6 O'Clock

Pipe Height: **10.8** (in.) Rod and Bar (Angled)  
Pipe Material: **Clay** ☐ Pipe Lined  
Invert Depth: **11.40** (ft.) Flow Characteristics: **Slow**  
Deposits: ☒ None ☐ Mud ☐ Sludge ☐ Debris ☐ Grease  
Silt Depth: **0** (in.) Deposits Extent:  
Infiltration: **None** Pipe Seal Cond: **Sound**

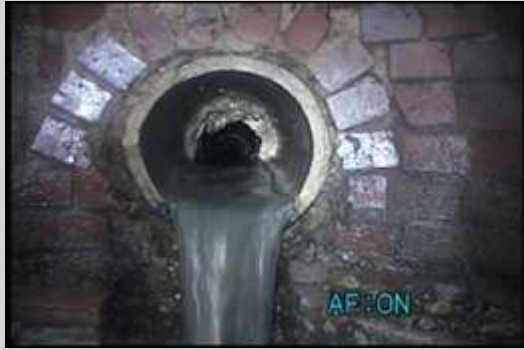
9 O'Clock Inflow

10 in. Circular Gravity Sewer

Pipe In @ 9 O'Clock

Pipe Height: **10.8** (in.) Rod and Bar (Angled)
